# Determination and Classification of Intraoral Photostimulable Phosphor Plate Artifacts in Dental Radiology

Luitel A, Bali H, Nyachhyon R, Gurung K, Shrestha R, Rijal A, Subedi R. Determination and classification of intraoral photostimulable phosphor plate artifacts in dental radiology: A retrospective chart review. *J Nepal Dent Assoc.* 2022 Jan-Jun;22(34):20-4.

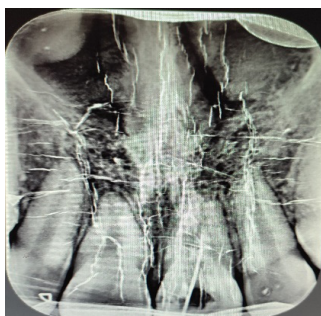
In the present study, 10,146 (86.76%) of the radiographs had artifacts. This figure is high as compared to other studies where the PSP plate radiographic artifacts ranged from 6-40%.<sup>2,4,5</sup> These intraoral radiographic artifacts were further categorised into three main categories: operator, PSP plate, and scanner related artifacts. The most common type of artifacts identified in this study was PSP plate related artifacts which was 14,682 (63.35%) (Figure 1). Under this, an artifact due to partial stripping of plate was seen in 7,548 (51.40%) while scratches were seen in 7,134 (48.59%) and they occurred together. The other similar studies had PSP plate artifacts between 9.30%-19.30%.<sup>1-5</sup> Partial stripping artifacts are seen as irregular radiopaque shadows on radiographic image due to partial stripping of protective coating of photostimulating luminescence layer of the plate.<sup>7</sup> This partial stripping can be due to, improper

**Figure 1: White arrow shows partial stripping artifact while black arrow shows scratch artifacts.**

handling of PSP plate, PSP scanner mismatch, and friction between roller of the scanner and PSP plates.<sup>8</sup> Use of compatible plate-scanner systems, professional manipulation of PSP plates and routine evaluation of PSP plates can help to avoid these artifacts.<sup>7-9</sup> However, because of propensity to scratch associated with deterioration of image quality, a study revealed that 95% of the PSP plates used for 10 weeks and more becomes undiagnostic and needs replacement.<sup>7</sup>

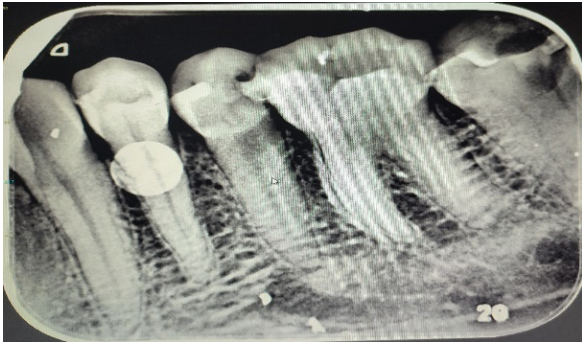
**Figure 2: Black arrow showing reverse film artifact.**

to reduce patient's discomfort. Foreign body artifacts are most common in PSP plate images of maxillary anteriors.<sup>3</sup> Most common are nose pins appearing as radiodense structures interfering with area of interest. Removal of these nose pins before the radiographic procedure will avoid this artifact. Reverse film artifact is seen as well-defined round radiopacity in the radiographic image when the PSP plate is kept reversed and the metal disk is exposed (Figure 2).<sup>3-5</sup> Thoughtful orientation and placement of the PSP plate inside the oral cavity helps avoid this artifact.

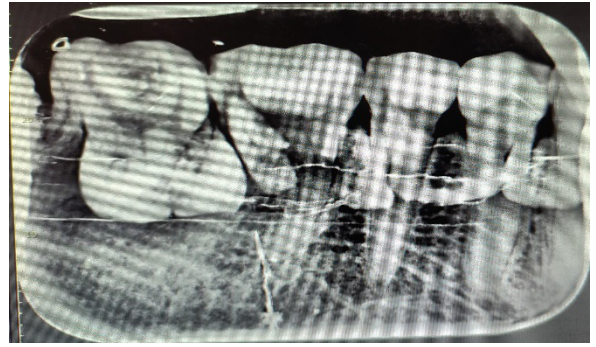
**Figure 3: Black arrow shows roller artifact while white arrow shows eraser unit artifact.**

Scanner related artifacts seen this study were just 1639 (7.07%) (Figure 3). Among these, 1636 (99.81%) were roller artifacts while, three (0.18%) was eraser unit artifact. This was synchronous to findings from other similar studies which reported 9.3%-10.3% of scanner related artifacts.<sup>1-5</sup> Roller artifacts appear as gray straight or zigzag lines of various radiopacities extending in fast or slow scan directions.<sup>2,12</sup> It appears due to dirt on rollers or

accumulation of dust or dirt on the light guide or reflector.<sup>12</sup> Cleaning of transport mechanism or light guide unit by service personnel helps reduce this error.<sup>2,12</sup> Eraser unit artifacts appear as ghost images of previous exposure due to defective light emitting diode (LED) causing inadequate erasing.<sup>2-4,12</sup> If there are repeated artifacts the eraser unit leads to be changed.<sup>3,4</sup>

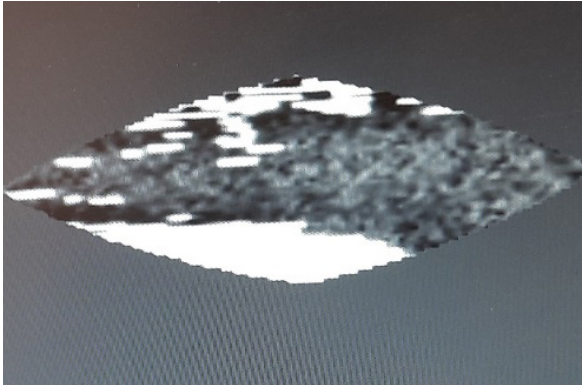
**Figure 4: Unidentified, laser unit error like artifact.**

In this study, nine (0.03%) of the artifacts remained unidentified (Figure 4 and 5). One (11.11%) resembled laser unit error artifact while rest eight (88.88%) of them were showing double images of two different regions with distinct two PSP plates outline. It appeared like two of the PSP plates were scanned together rather than an eraser unit artifact.

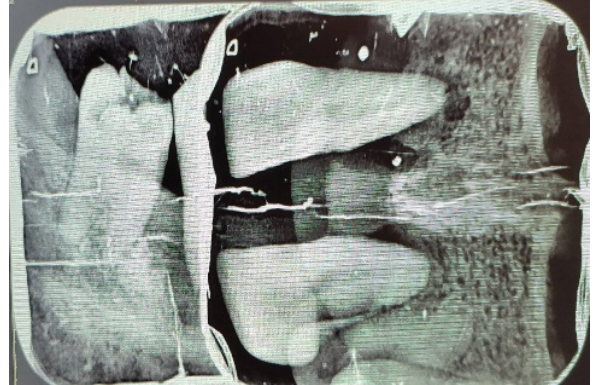
**Figure 5: Unidentified, double image like artifact.**
