Retrieval Of An Overextending, Separated Instrument From The Canal Of A Lower Molar – A Case Report

This case report illustrates using Masserann technique to successfully retrieve an overextending, separated instrument from the root canal of lower first molar.

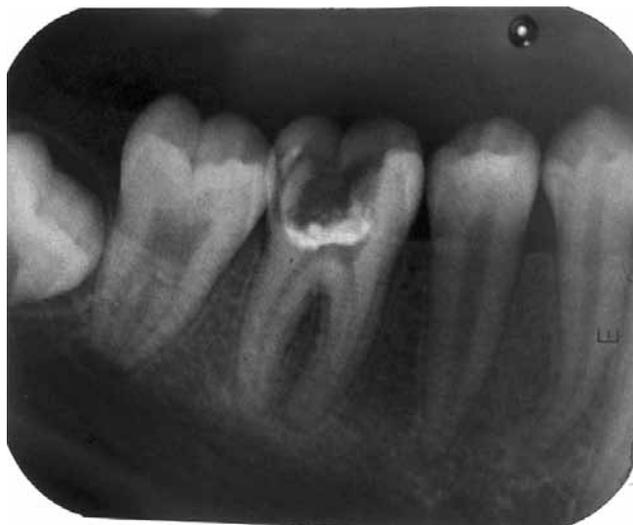
A 17 year old female patient reported with a chief complaint of severe pain in the lower left molar area while chewing. Clinical examination revealed gross and deep occlusal caries in mandibular left first molar (tooth 36). The tooth 36 was sensitive to percussion. Periapical radiographic examination of tooth 36 showed the close proximity of caries to the pulp space with remnants of temporary cement and apical widening of the periodontal ligament space of the mesial root (Figure 1).

Figure 1: Preoperative periapical radiograph of tooth 36 showing the extensive caries with remnants of temporary cement and apical widening of the mesial root periodontal ligament space.

Since thermal and electric pulp testing gave negative response, a diagnosis of pulp necrosis with acute apical periodontitis was made and root canal treatment was suggested in tooth 36. Following access refinement and working length determination in tooth 36, canal cleaning and shaping was initiated in a crown down manner using rotary Nickel-Titanium files (ProTaper, Dentsply Maillefer, Ballaigues, Switzerland). However, during cleaning and shaping, size F1 file was separated in the mesio-buccal canal.

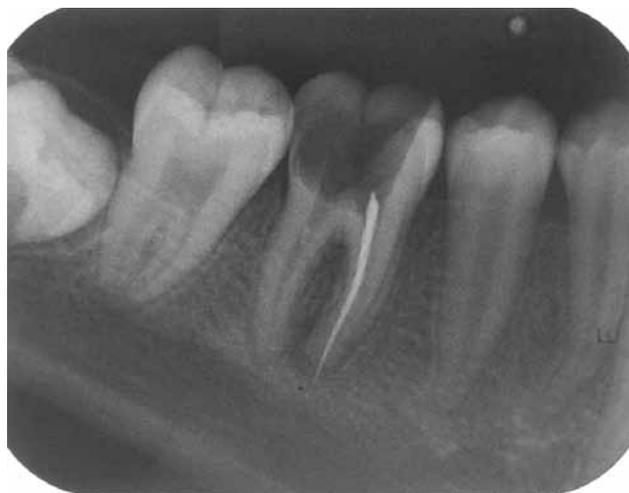
Clinically, the separated fragment of the file was found tightly wedged into the canal with minimal extension into the pulp chamber. A periapical radiograph of tooth #36 revealed that the separated fragment was occupying the entire length of the canal and overextending periapically by around 1.5 mm (Figure 2).

Figure 2: Periapical radiograph of tooth 36 showing the separated instrument lying in the entire canal and overextending periapically.

Since the fragment could not be bypassed nor be grasped coronally, a decision was taken to use ultrasonic vibrations for retrieval. A C6 ultrasonic tip (NSK, Japan) vibrating at a low power output was kept against the fragment and run in a counter-clockwise direction. Although this appeared to partially loosen the fragment, the fragment could not be removed as it was overextending periapically. Therefore, a Masserann kit (Micro Mega, Besancon, France) was employed to grip and retrieve the fragment. Since there was some space between the coronal end of the fragment and root canal wall, the kit was used without trephining or cutting the dentin. The remaining external portion of the separated file was used as a guide to select an extractor tube. The extractor tube with a diameter of 1.5 mm was found suitable to grip the fragment. The tube was slid into the coronal space to encircle the fragment and the plunger rod was inserted into the tube and turned in a clockwise direction to lock the coronal end of the fragment against the wall of the tube. The tube with the locked fragment was gently rotated in an anticlockwise direction to retrieve the fragment (Figure 3).

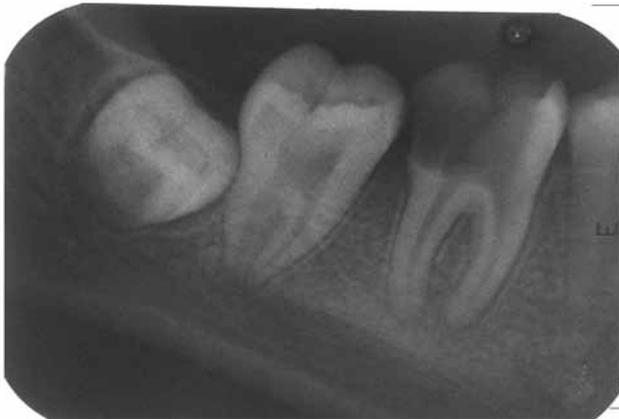
The time taken for the retrieval was less than 30 minutes. The retrieval of the fragment was radiographically confirmed (Figure 4).

Figure 4: Periapical radiograph confirming the retrieval of the metallic obstruction from the root canal of tooth 36.

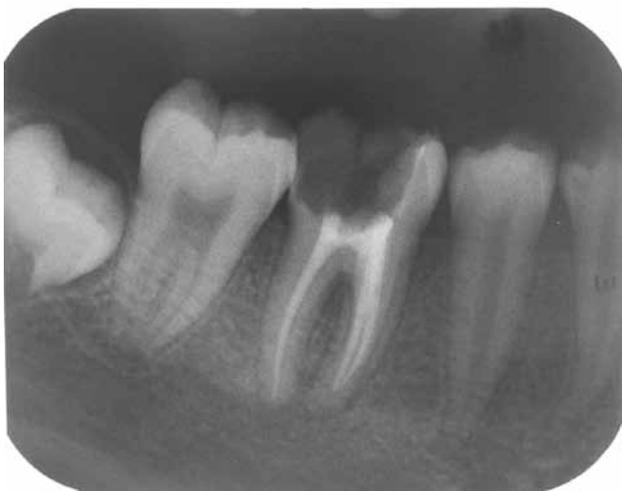
In the subsequent visits, canal cleaning and shaping was completed and obturation was carried out using gutta percha (ProTaper, Dentsply Maillefer) master cones and AH26 sealer (De Trey Dentsply, Konstanz, Germany) (Figure 5).

Figure 5: Periapical radiograph following the obturation of 36. The access opening was restored and tooth was cemented with full crown. In the follow up visit, the tooth was found asymptomatic without any significant radiographic changes (Figure 6).

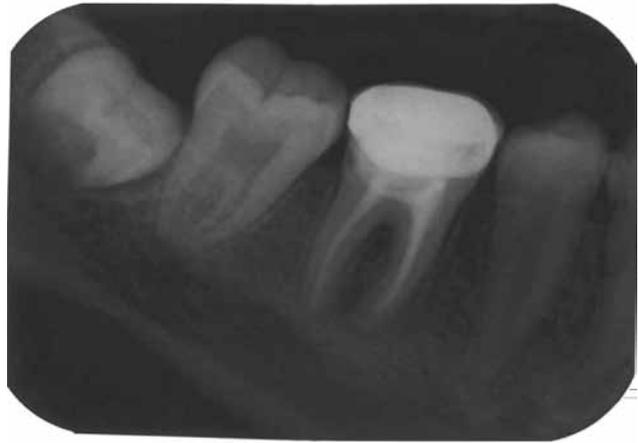
Figure 6: Follow up radiograph of tooth 36 showing no significant radiographic changes.
